February 24, 2012

MEMORANDUM

SUBJECT: First quarterly cap inspection at the San Jacinto River
Waste Pits superfund site

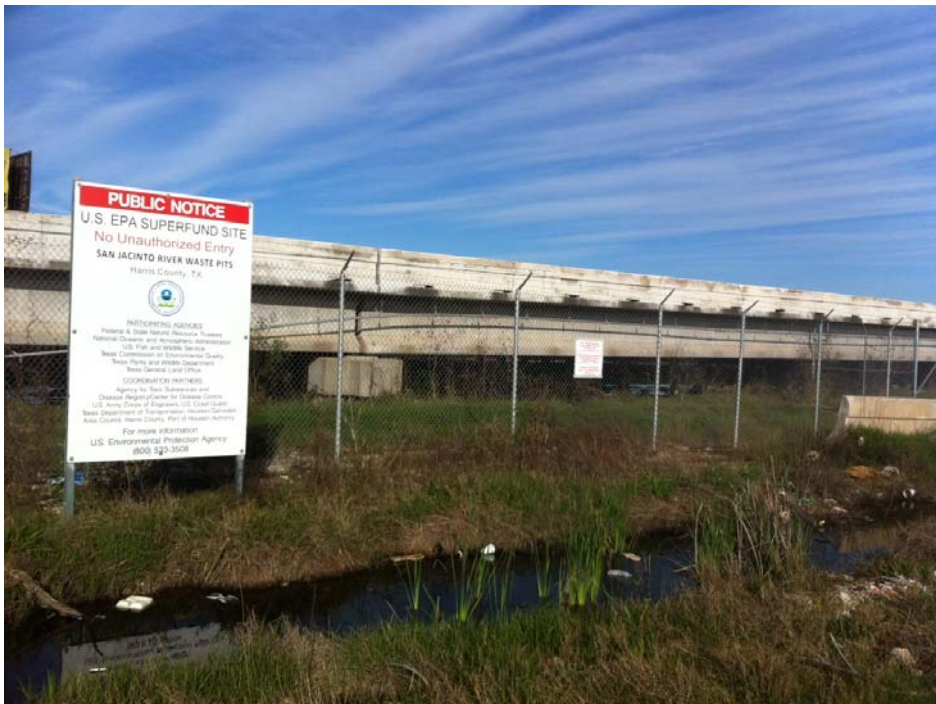
Photo 1- View of Site perimeter fencing and Site signage South along I-10, West of San Jacinto River

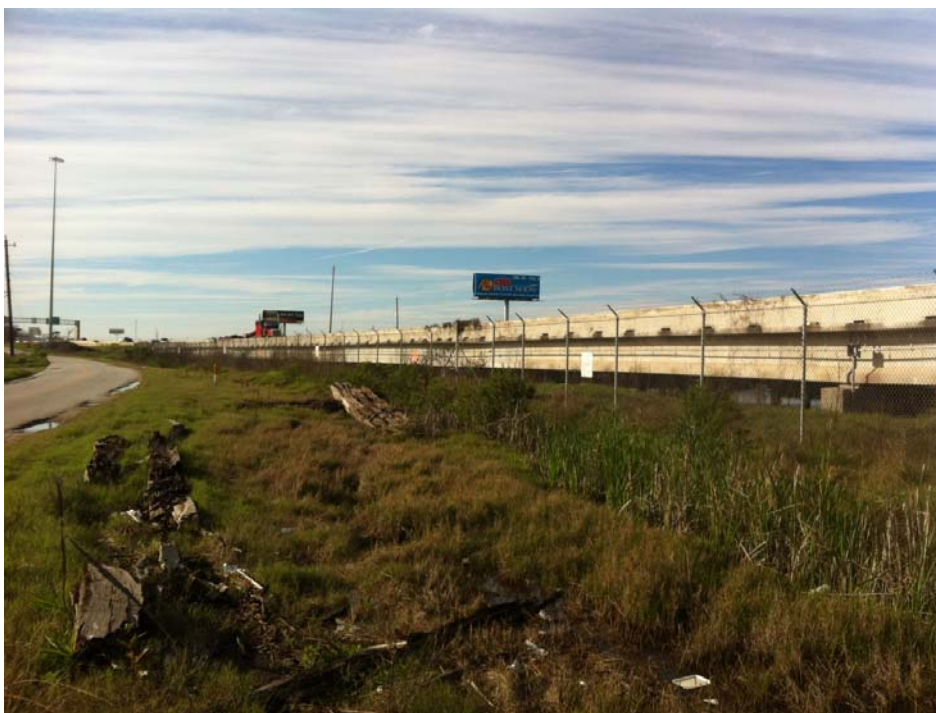
Photo 2- View of Site perimeter fencing South along I-10, West of San Jacinto River

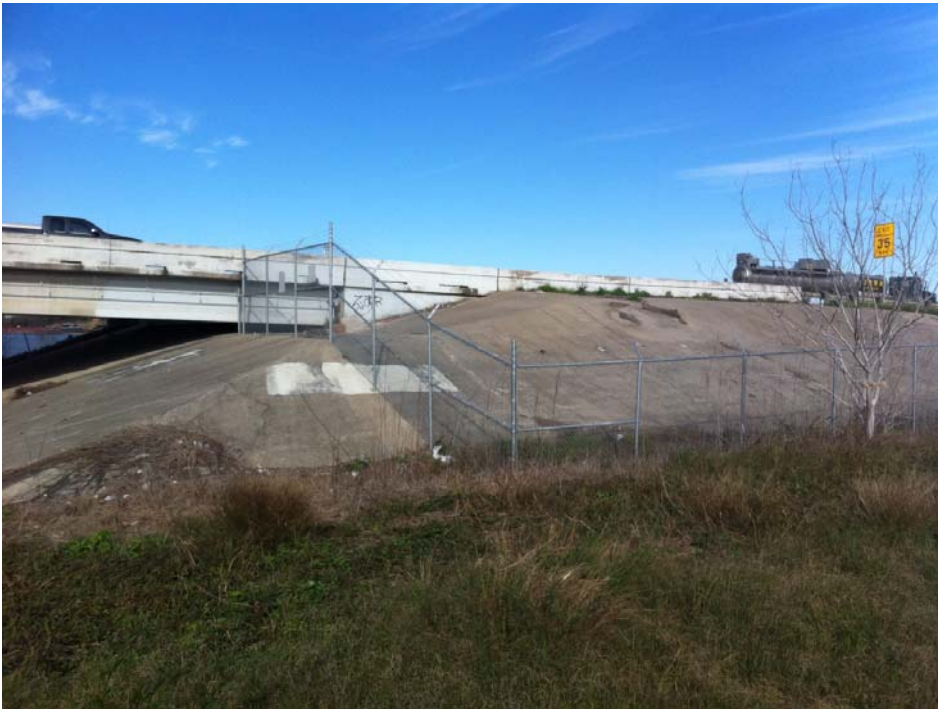
Photo 3- View of Site perimeter fencing South along I-10, East of San Jacinto River

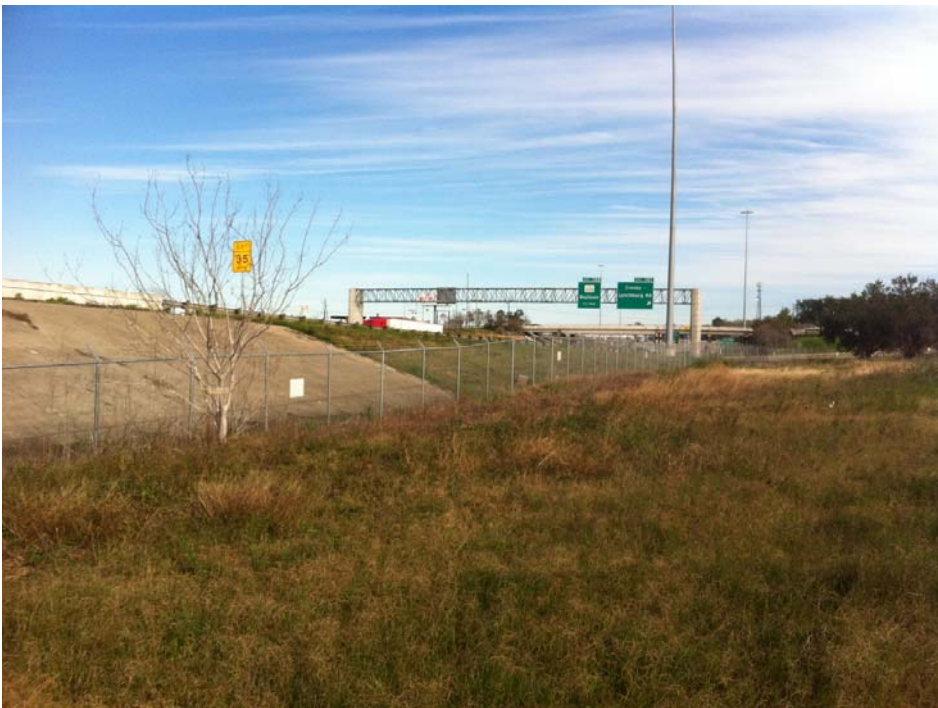
Photo 4- View of Site perimeter fencing South along I-10, East of San Jacinto River

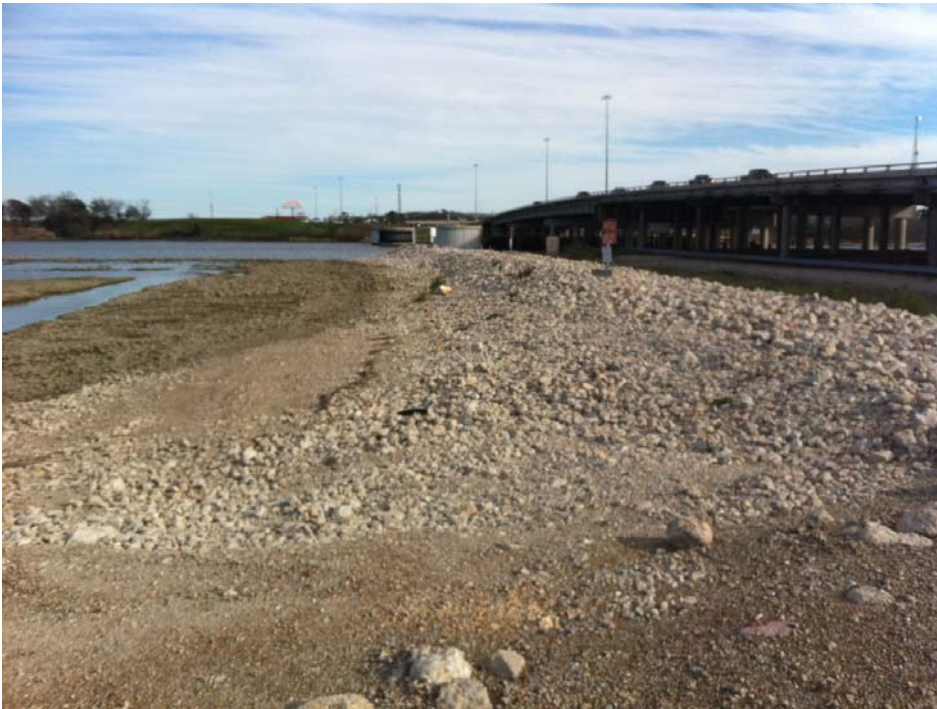
Photo 5- View of armor cap's southern berm North of I-10, West of San Jacinto River

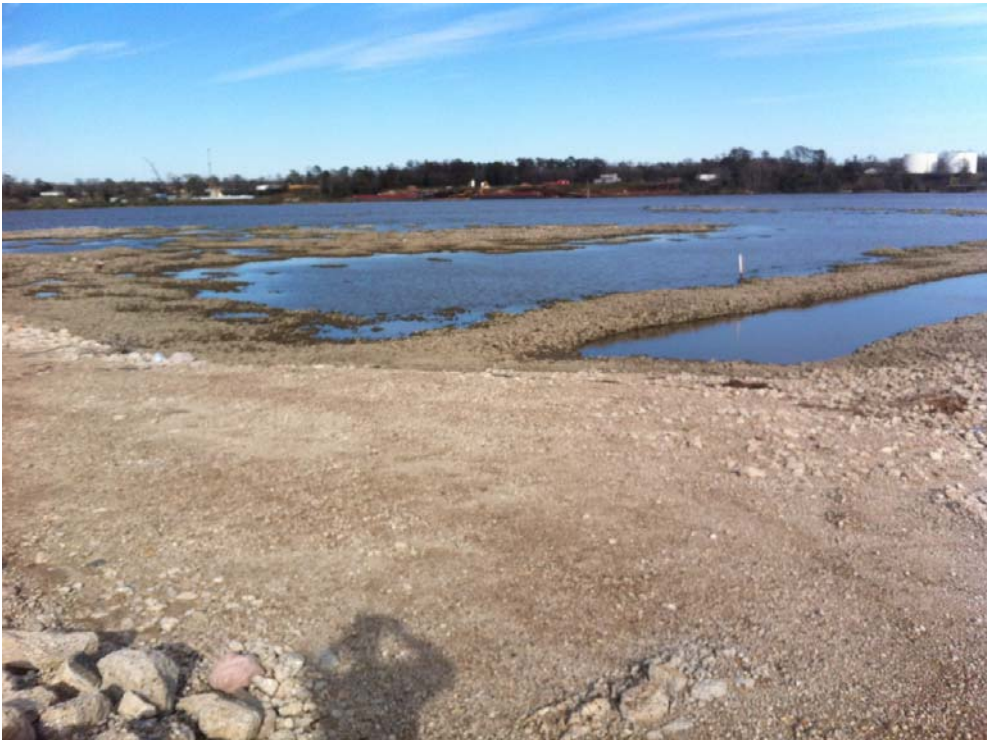
Photo 6- View of eastern impoundment of armor cap North of I-10

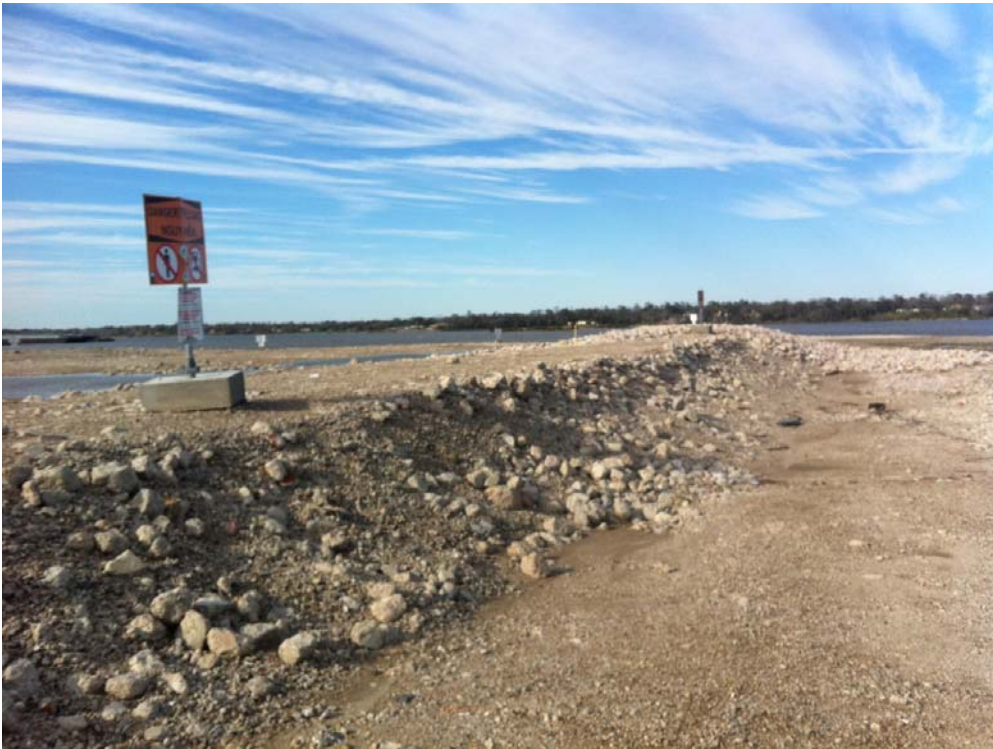
Photo 7- View of central berm and eastern impoundment of armor cap North of I-10

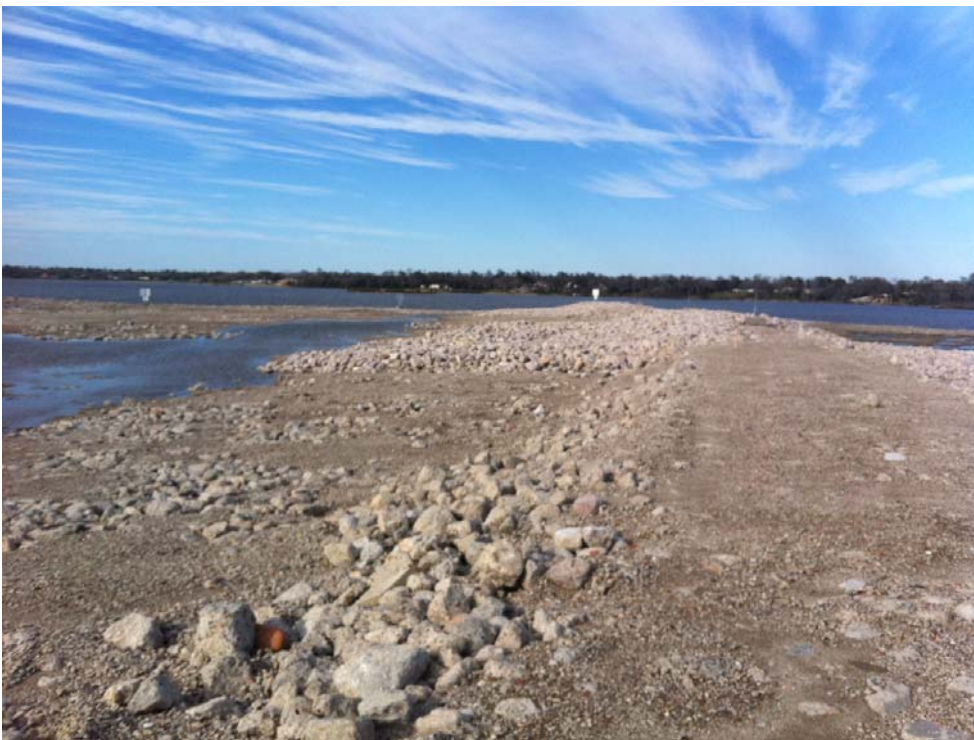
Photo 8- View of central berm and western impoundment of armor cap North of I-10

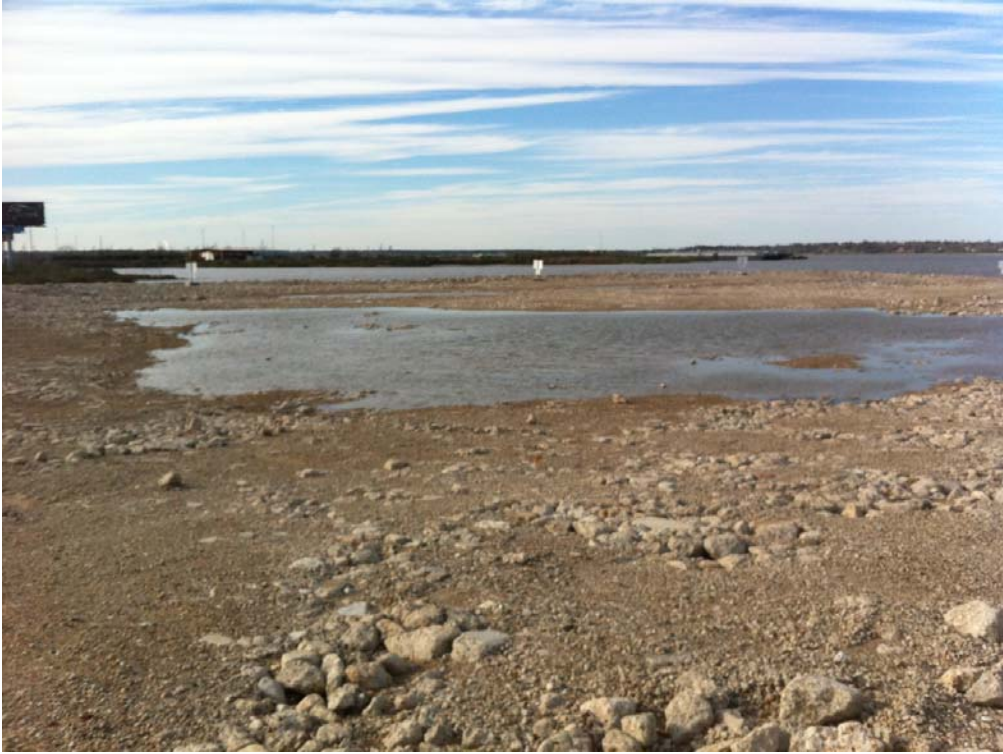
Photo 9- View of western impoundment of armor cap North of I-10
